OHIO SCHOOL BUS STANDARDS AND INSPECTION MANUAL

2024

OHIO STATE HIGHWAY PATROL LICENSING AND COMMERCIAL STANDARDS

Revision Date: January 2024

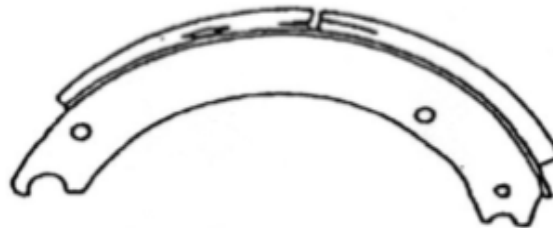
Out-of-Service
Cracks or voids that exceed 1/16" in width.
Cracks that exceed 1-1/2" in length.
